# Home Inspection Report

Sample report

April 2, 2004

Sample report  
Phoenix, AZ

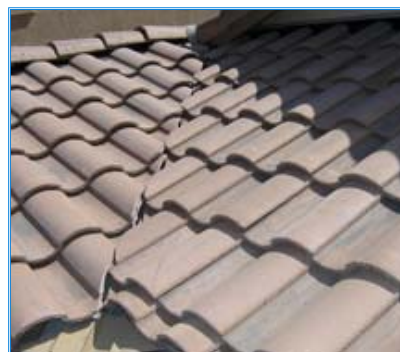
The roofing inspection was conducted from the roof. The roofing materials are concrete tile roofing. A concrete tile roof consists of preformed, interlocking tiles that are cast from concrete and fastened to the substrate with metal clips or by either nailing or screwing. Concrete roofs are very durable, but care must be taken when walking on them as stepping onto tiles at the wrong location can crack them. These roofs can be badly damaged by moss growth that is left unchecked, but when properly cared for have an expected service life in excess of 50 years.

The building does not have any gutters. This may result in moisture damage to, or cause unsightly mud spattering of, the exterior siding. It is recommended that gutters be installed.

The roof appears to be in good condition. Only routine maintenance is recommended.

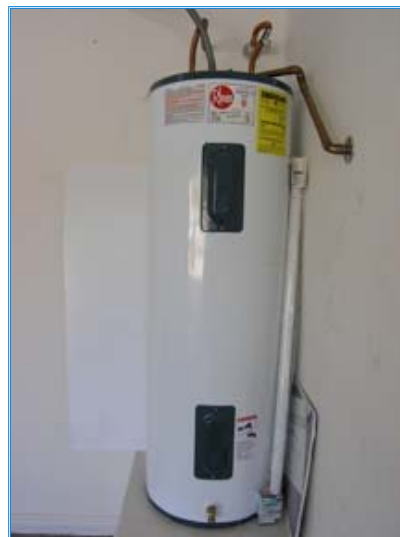
Hot water for the residence is provided by a conventional storage tank with 50 gallons of capacity. The energy source for the water heater is electricity. The water heater date of manufacture is 6/2003. The water heater is located in the garage. The water heater is located in the Garage.

We examined, as closely as possible, all visible and accessible plumbing supply and waste components in this home and did not find any readily evident deficiencies. This is not a guarantee that the plumbing of the home is defect-free, as there are portions of the plumbing that were concealed from view and are inaccessible for inspection purposes.

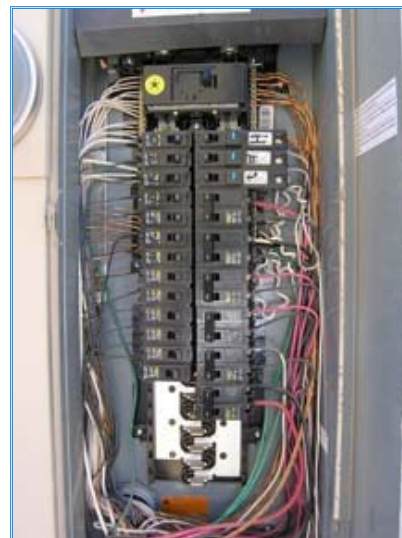
Electrical service to the home is via underground service lateral. The service entrance conductors were not viewable. The electrical meter is located on the North side of the residence. The service grounding electrode conductor is a stranded copper ground located on the ufer ground. The main disconnect is a 200 amp breaker type located inside the service entrance panel. The main service entrance panel is located in the North side of the residence. The final service rating is 200 amps. The main service panel appears to have some room for future upgrades or additions to the system.

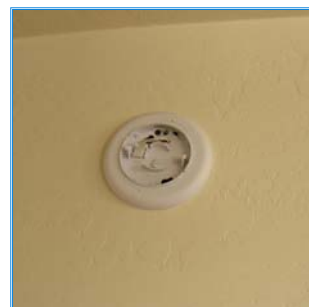
Smoke alarms were found in the building, but not installed. It is recommended that the alarms be installed before the home is occupied.

The Fire Code requires alarms in all hallways that lead to bedrooms. It is a standard recommendation that smoke alarms are located where they will not be triggered by steam and/or fumes from bathrooms or kitchens. The smoke alarms were tested and some were found to be not working. Further investigation by a licensed electrician is recommended.

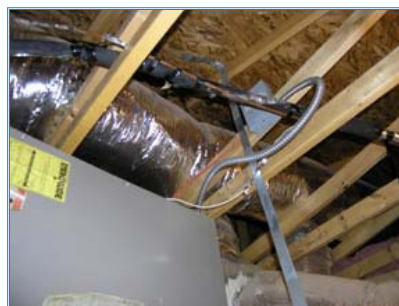
MAKE: Goodman  
MODEL: AR61-1  
SERIAL: 0304446902

The heating system is located in the attic and was accessed by entering through an attic hatch. No inspection tag was found on the heating system at the time of the inspection. The electrical safety switch for the heating system is located at the furnace unit. The thermostat for the system is a programmable type and is located in the main floor hall. It is recommended that the client(s) have the homeowner provide the instructions for programming or show the client(s) how to do so.

Heating unit was not checked for heating function due to time of year and potential for damage if switched from cooling to heat and then back again.

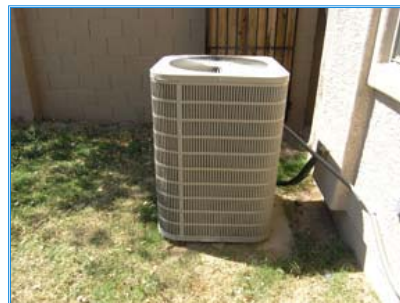
MAKE: Goodman  
MODEL: CPLJ48-1  
SERIAL: 0304491840

The compressor unit is located at east side of the home. The ductwork for the heating system consists of flexible, insulated, polyethylene ducts with polyethylene return ducting. The filter is at the return air intake grill(s).

The proper temperature split between supply and intake air in an air conditioner is 14 to 20°F. This system is operating within specified temperature limits.

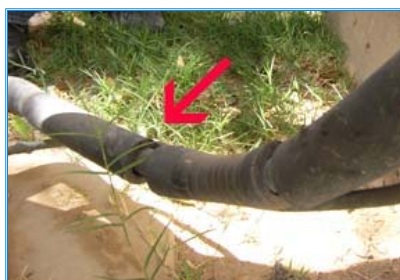
The insulation on the AC line from the compressor unit to the home is cracked and missing in places, this insulation needs replacing.
